GUTHRIE LAKE DAM
CALLAWAY COUNTY, MISSOURI
MO. 10990

**PHASE I INSPECTION REPORT
NATIONAL DAM SAFETY PROGRAM**

GUTHRIE LAKE DAM
CALLAWAY COUNTY, MISSOURI

SEPTEMBER 1980

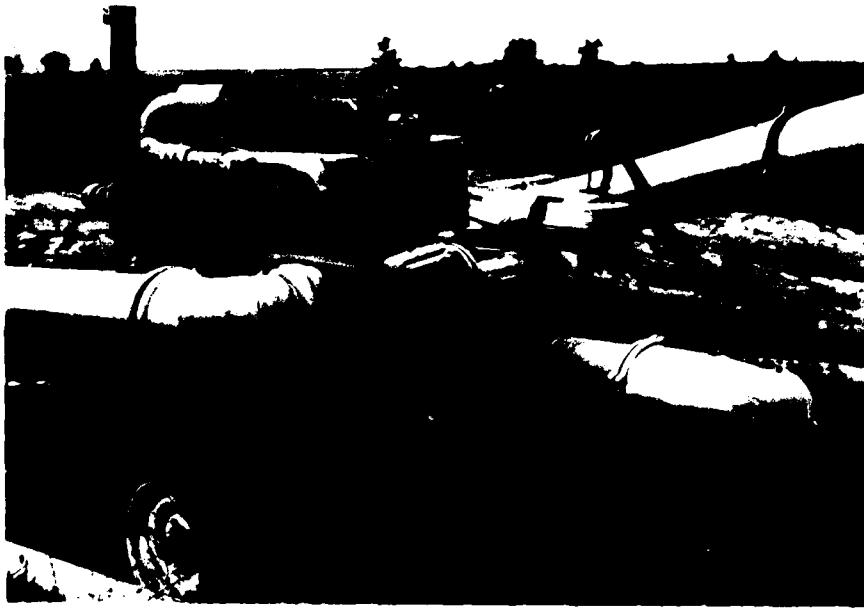
Photo 11

No low-level outlets or outlet works were provided for this dam; however, a portable, diesel powered, centrifugal pump is used at the damsite (see Photo 11). The pump is used to pump water from the reservoir to a central pivot irrigation sprinkler system on the reservoir rim. According to Mr. Guthrie, the pump has a capacity of 1,100 gallons per minute (gpm). The pump was last used during the summer of 1979.

There are no low-level outlets or outlet works provided for this dam. However, a portable, diesel-powered centrifugal pump, which cannot be considered an appurtenant structure, is used at the damsite. The pump is operable and is capable of draining the reservoir, according to Mr. Guthrie. The pump was last used during the summer months of 1979.
